AN OPERATIONAL RESEARCH INVESTIGATION OF THE  
ICE-DETECTION CAPABILITY AND UTILITY OF THE  
SURFACE CONDITION ANALYZER (SCAN) SYSTEM  
AND ITS APPLICABILITY TO NAVY-WIDE USE

Calspan Report No. 6283-M-1

MARCH 1979  
CONTRACT NO. N00014-78-C-0284  
FINAL REPORT

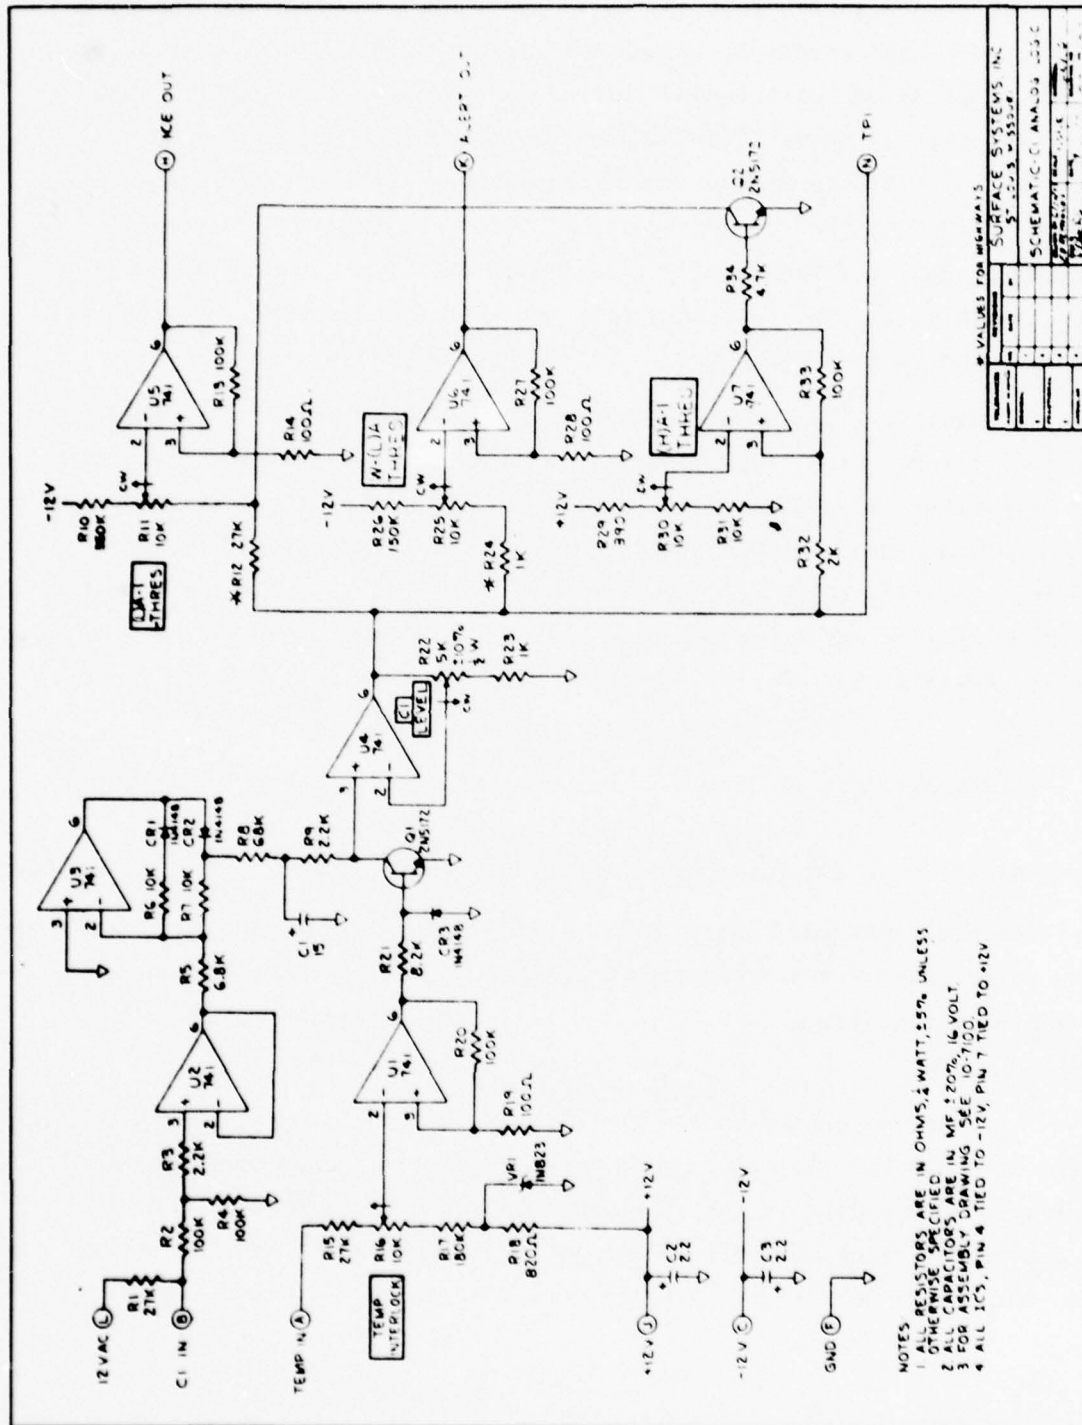
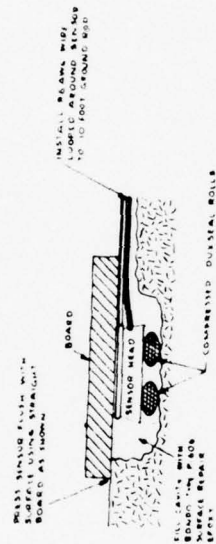
DETAIL OF AIR TEMPERATURE SENSOR HOUSING Figure 7 SCAN INSTALLATION DETAILS  
(Figure courtesy of SSI)

The sensors mounted in the runway are embedded in epoxy plastic. The sensor assembly has the approximate appearance of a hockey puck (Figure 7) and is secured in a cavity in the runway by casting epoxy around it. A typical sensor installation is shown in Figure 8. During the casting operation, its surface is kept flush with the runway surface by a board that

resists the pressure exerted by rubber balls or rollers compressed below the sensor puck (Figure 7, Detail-Sensor Installation W/Cord to Edge of Runway). Wires from the sensor are run in a narrow, epoxy-filled cut in the runway to its edge (Figure 8a).

In older versions of SCAN, permittivity (C2) was measured at a frequency of 200 kHz - to cause sufficient current to flow in the small capacity of P1 (Figure 4). At this high frequency, an amplifier was needed at a distance of about 8 meters from the sensor puck. The amplifier package (80 x 100 x 180 mm) was buried after being spliced into a polyvinyl chloride (PVC) covered cable. An adjustment screw on the package was sealed with silicone rubber (RTV). It is believed that hosing (capillary transport of water in the gap created by compression of PVC under hydrostatic pressure (Figure 9)) caused moisture damage to these amplifiers. They have since become obsolete, and a 5 kHz signal has replaced the 200 kHz bridge generator. It now proves practical to run cables up to 150 meters from the sensor but runs of  $25 \pm 5$  meters are preferred (Figure 7, System Component Locations for a Typical 10,000 Foot Runway).

A Remote Processor Unit (RPU) is placed at the end of the sensor cable (Figure 7, Detail-Typical Field Installation of RPU). It provides power to and receives signals from the sensor puck, receives 120 V AC power from power lines, and communicates runway condition data to display monitors, either by radio links or wires (typically buried). (See Figure 7, 7000 Series RPU and 5 Channel Monitor Connection Detail, and Figure 10, RPU Block Diagram.) The RPU contains most of the processing circuits discussed earlier in Section 4.3. Further details of the RPU are provided in the following Section, "Construction of System Components".

The air temperature sensor can be conveniently mounted near a Display Monitor on the airport. It is usually directly wired to the display (Figure 7, 7000 Series RPU and 5 Channel Monitor Connection Detail).

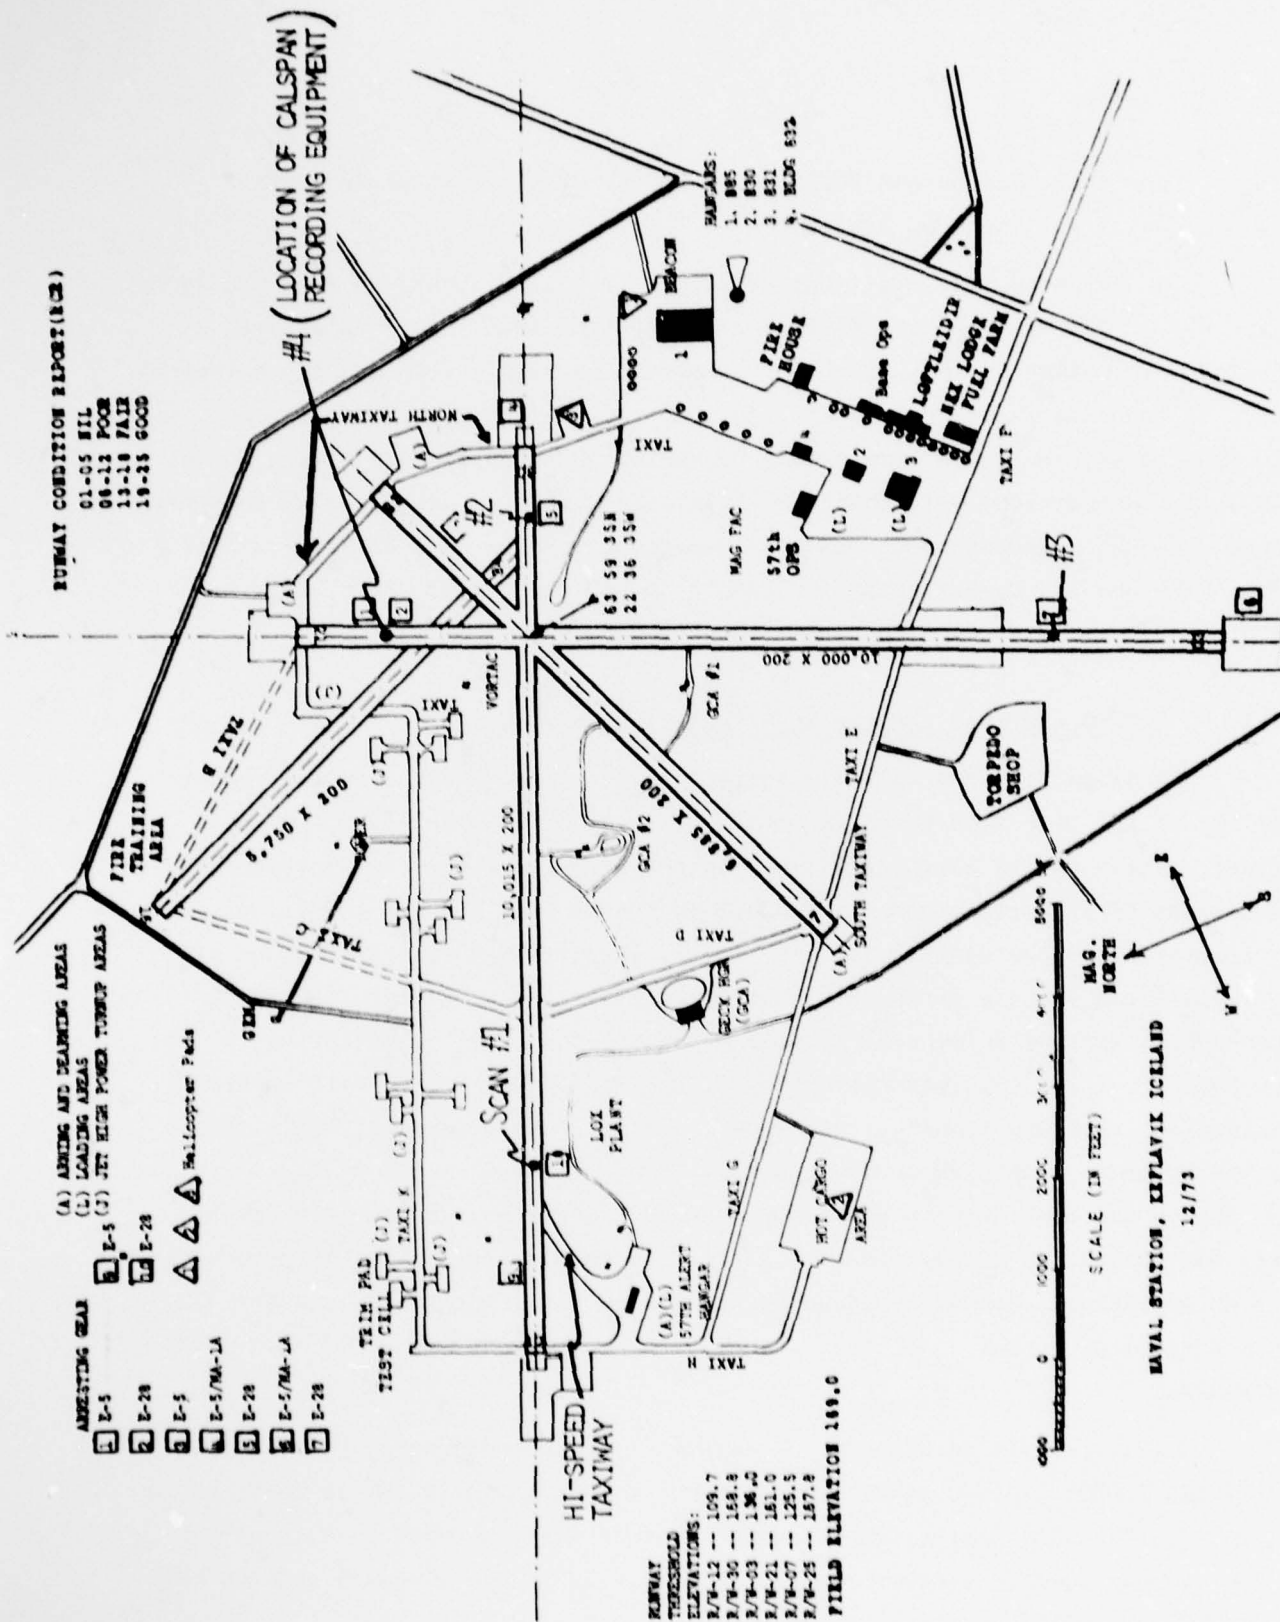
Figure 12: SCHEMATIC LAYOUT OF KEFLAVIK NAS SHOWING LOCATION OF SCAN SENSORS ON THE RUNWAYS

The airfield at USNASKEF is comprised of two main perpendicular runways (03-21 and 12-30) and two shorter cross runways (07-25 and 34-16) as depicted in Figure 12. The SCAN system, installed at USNASKEF in September 1976, consists of four runway surface sensors located\*respectively at the approach ends of the

\*The sensors are implanted ~40 ft (12m) from the runway centerline.

two main runways, two readout stations (at the Fire Department Communications Center and at SIRC Operations Building) and two air temperature sensors located on the roofs of the respective readout-station buildings. A photograph of the runway installation of SCAN sensor #3 is shown in Figure 8 (Section 4). (The two stripes leading onto the runway shown in Figure 8a are the epoxied cuts in the runway surface for the cable runs from the old and new SCAN sensor heads.)

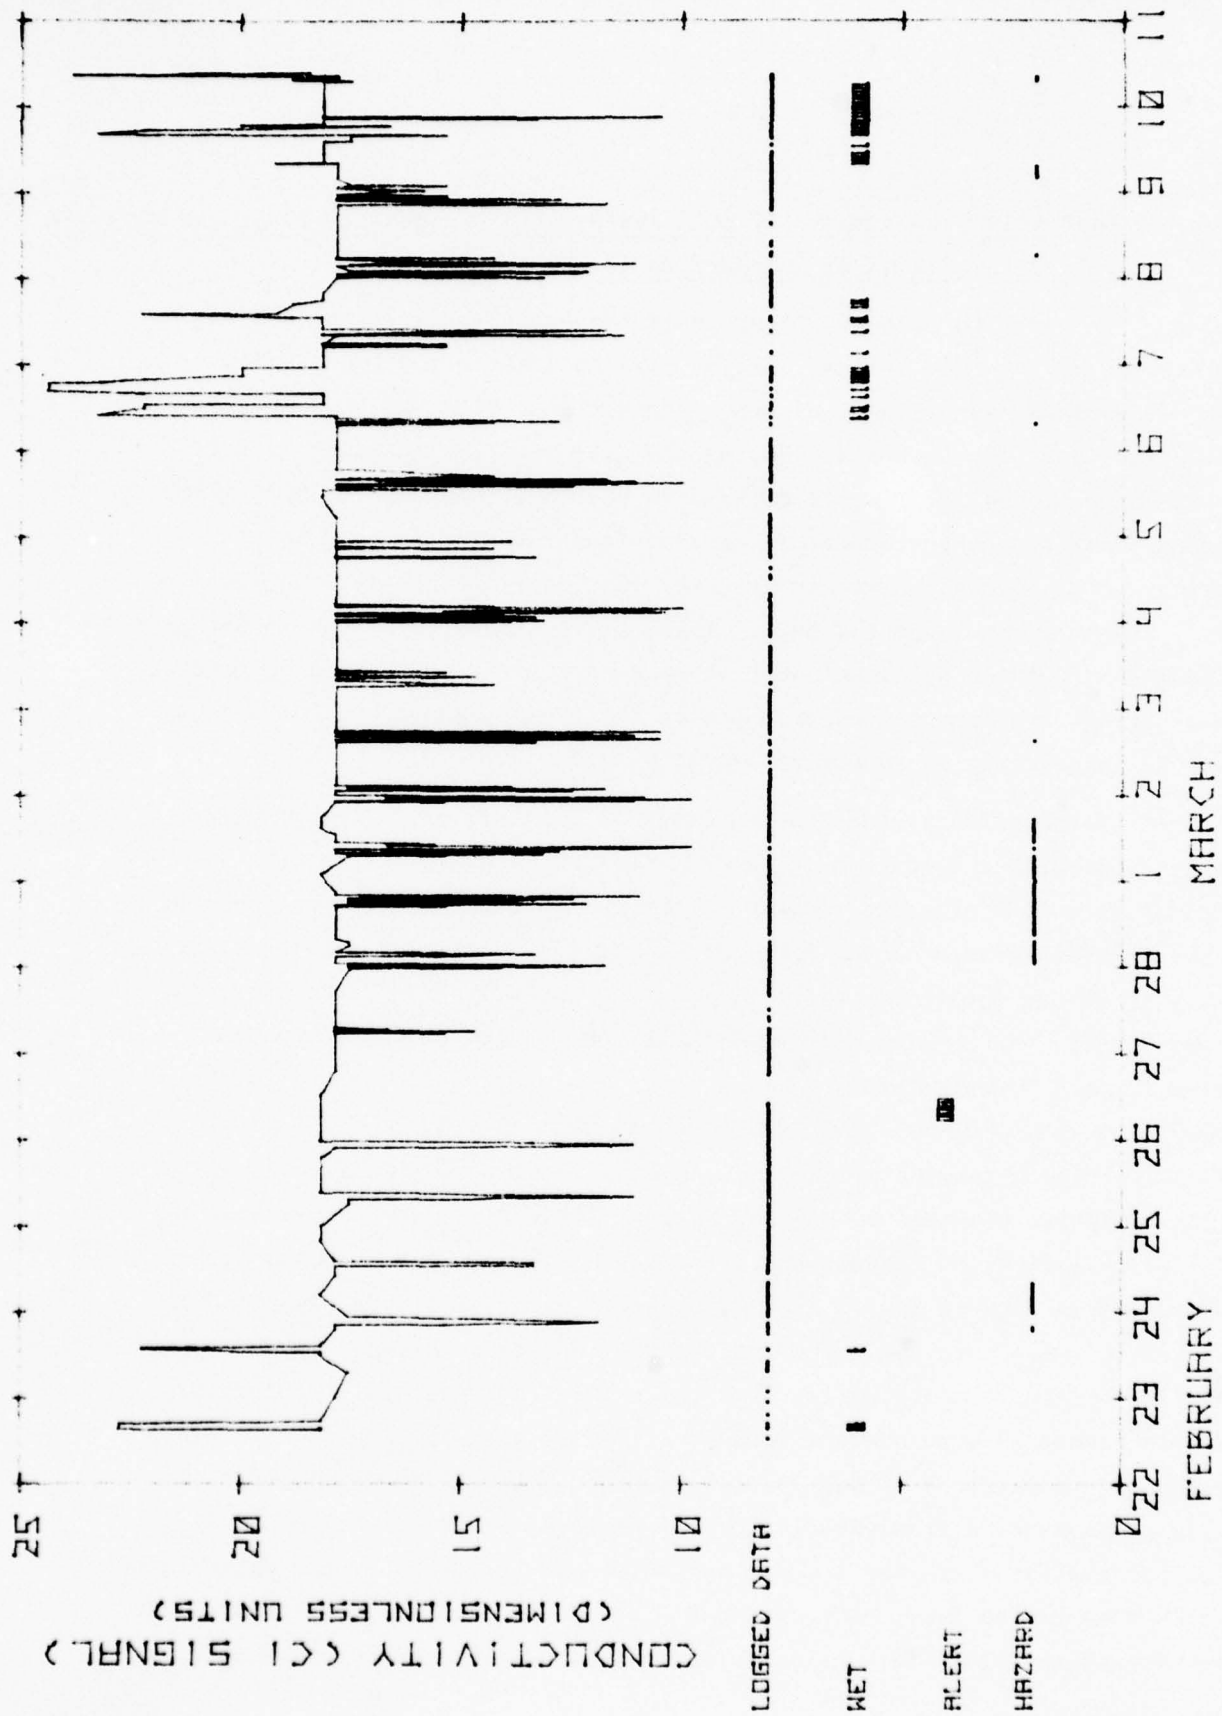
Figure 15: RECORD OF THE CONDUCTIVITY SIGNAL OF SCAN #4 AT KEFLAVIK, 22 FEBRUARY-10 MARCH 1978

The recording system at SCAN sensor #4 was installed on the afternoon of 22 February, and, as an initial test, the sensor was splashed with water to depth of ~0.5 mm from ~1530-1700 GMT. The response of the conductivity and capacitance sensors to the layer of water can be seen in the spikes in Figures 15 and 16, respectively. On the following afternoon (23 Feb.) at ~1400, an attempt was made to calibrate the surface temperature probe\* of #4 by creating a puddle of water ~10 mm deep over the sensor and measuring the temperature of the water with a thermometer. Again, note the spikes in the records shown in Figure 15 and 16 on the afternoon of 23 February. In both tests (ie., on the afternoons of 22 and 23 Feb.) the SCAN sensor responded to the presence of a substantial layer of water, measuring, as expected, increases in both capacitance and conductivity.

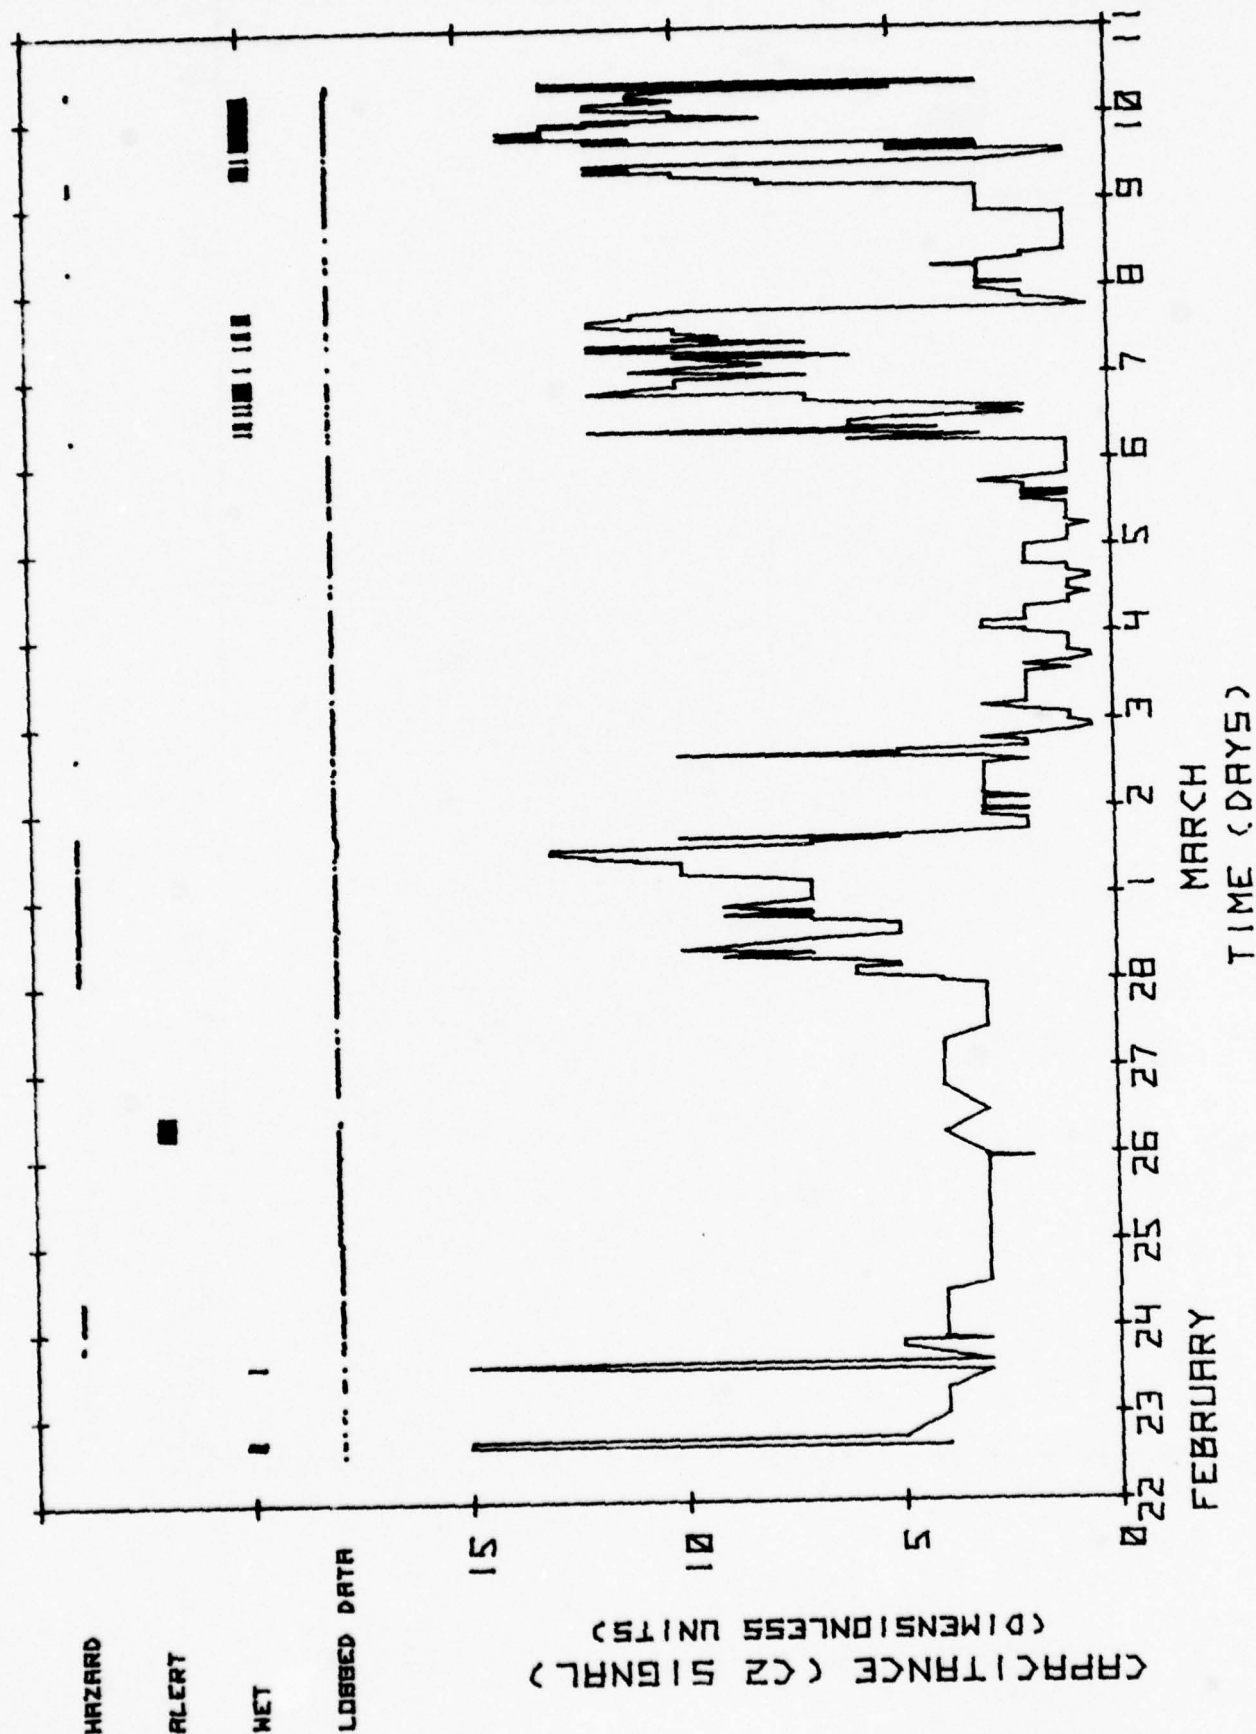
Figure 16: RECORD OF THE CAPACITANCE SIGNAL OF SCAN #4 AT KEFLAVIK, 22 FEBRUARY-10 MARCH 1978

The logic involved in the SCAN system's determination of surface condition is readily apparent from a review of the data presented in Figures 15-18. It is obvious that a surface condition other than CLEAR (dry) was indicated whenever the capacitance signal (Figure 16) increased a certain amount above the baseline value. It is equally obvious, from a comparison of Figures 16, 17 and 18, that HAZARD signals (as opposed to WET, with a high value of capacitance) were generated when recorded surface temperature (Figure 17) was 0°C (32°F) or lower (e.g., on the mornings of 3, 6, 8, 9 and 10 March). The conductivity probe, while capable of detecting water (both tap and rain; e.g., see 22, 23 February and 6 and 7 March on Figure 15), apparently played no role in signal processing. Therefore, for sensor #4 at Keflavik during the period 22 February-10 March 1978, the capacitance signal determined the presence of water on the sensor, and surface temperature was used to determine the phase of the water.

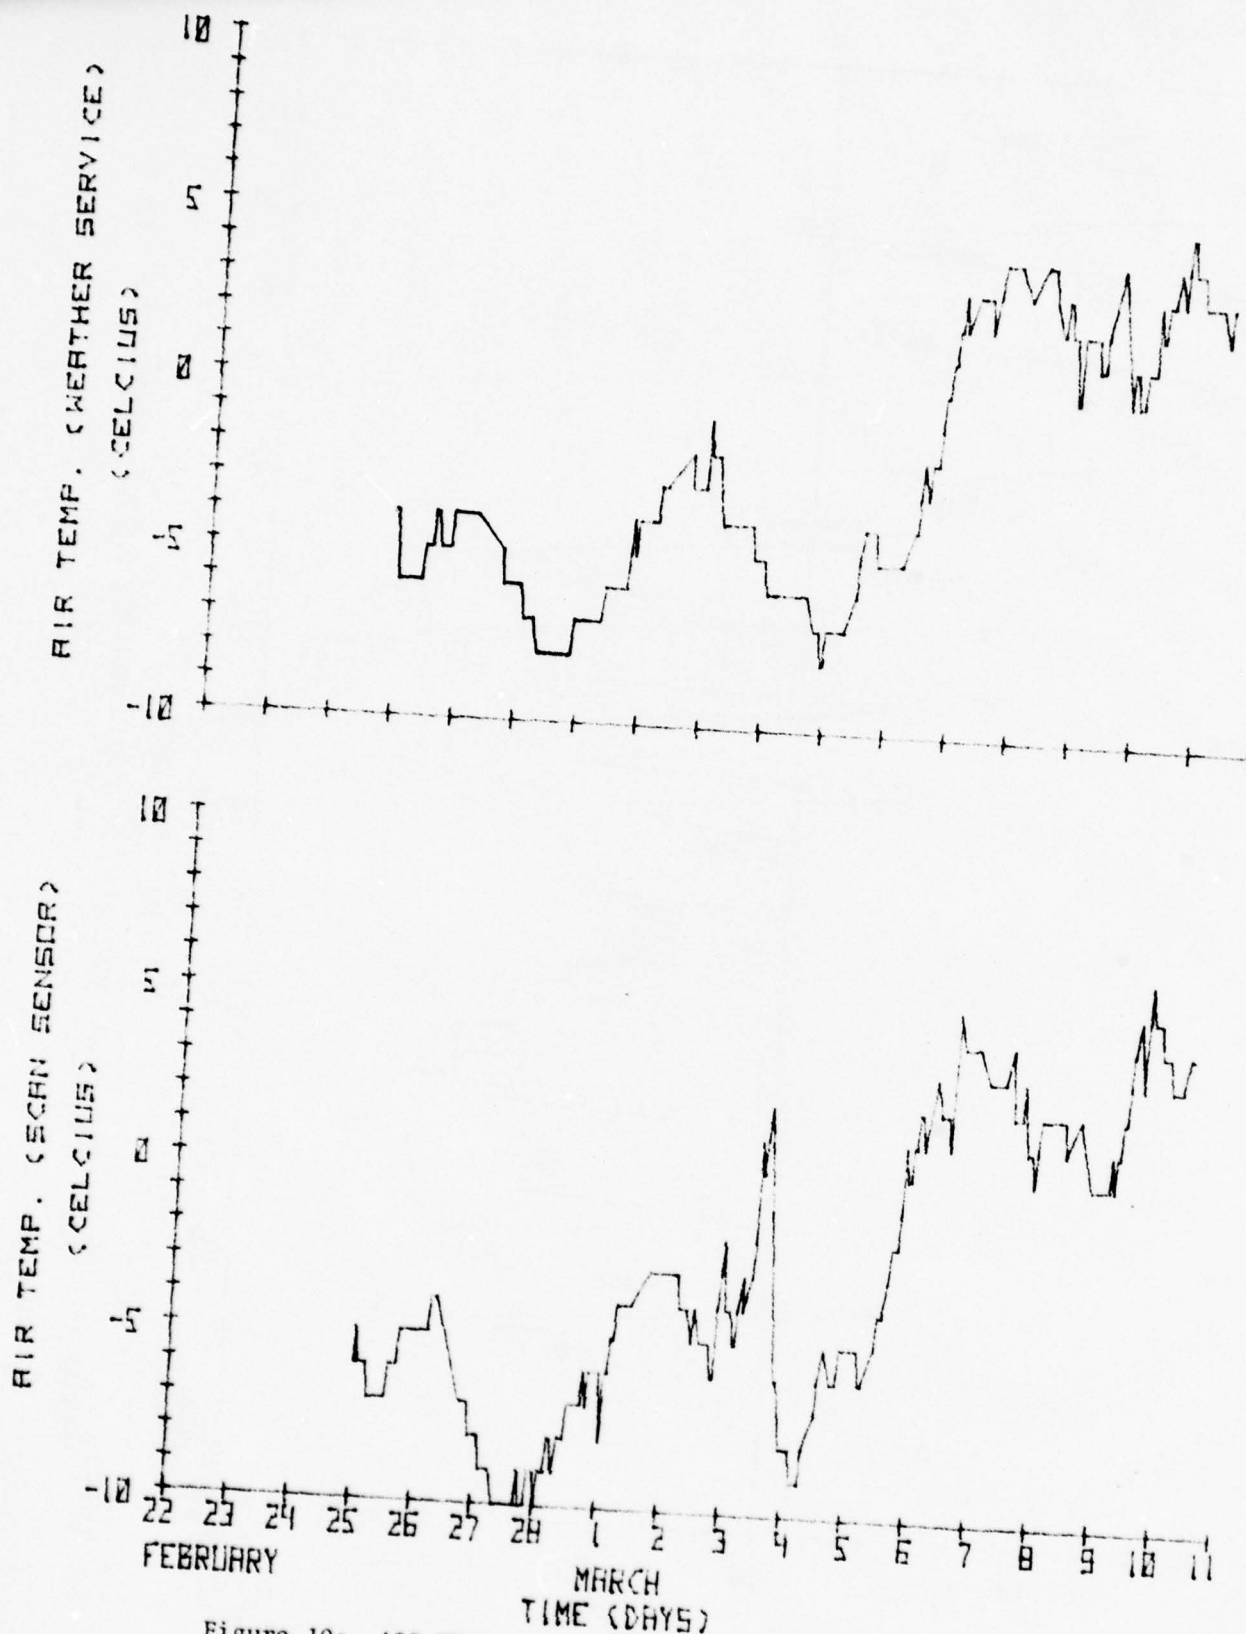
Figure 19: AIR TEMPERATURE RECORDS FROM THE SCAN SENSOR AND THE NAVAL WEATHER SERVICE

measured by the SCAN system are compared with similar hourly observations reported by the Naval Weather Service in Figure 19. (Dewpoint and wind speed data from the Naval Weather Service Records are provided in Appendix B.) The time marks on these figures refer to the 0000 hour (GMT and Local) of the indicated days.

Hourly data from the SCAN air temperature sensor and similar data from the Naval Weather Service records are compared in Figure 19. Given the differences in exposure of the two instruments, the air temperature data exhibit reasonably good agreement.

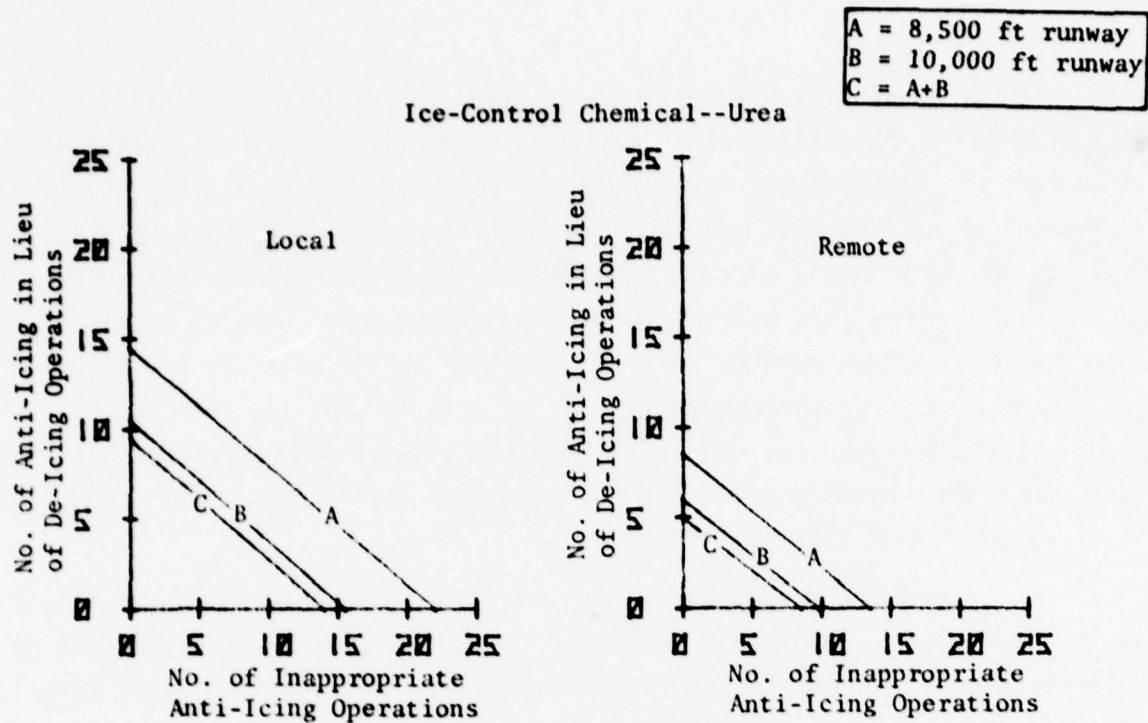
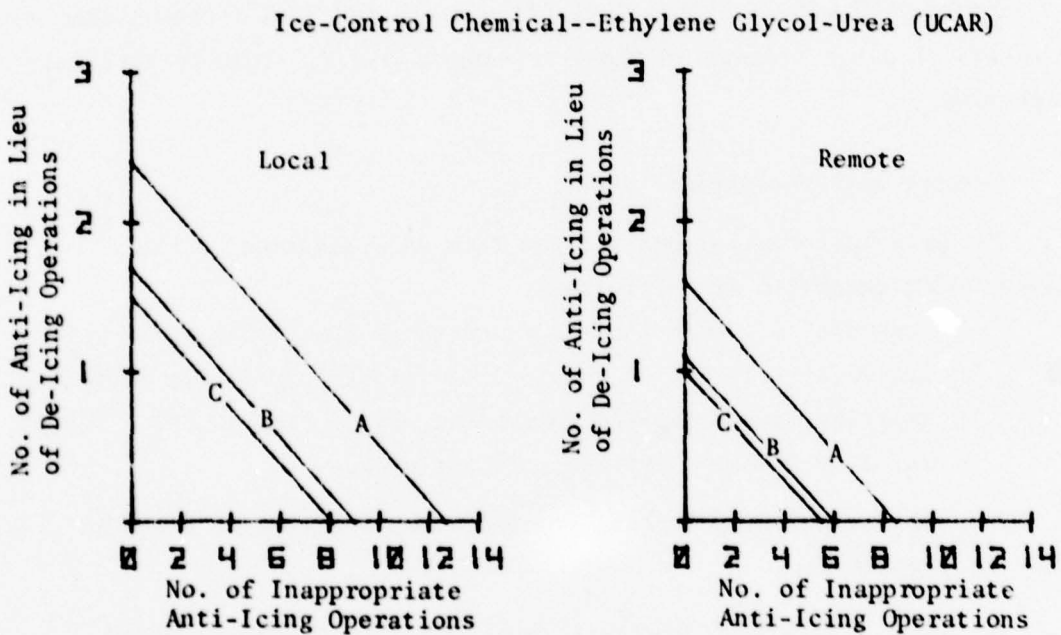
Figure 22: Breakeven Analysis: Trade-offs Between the Number of Inappropriate Applications of Ice-Control Chemicals and the Number of Implementations of Anti-Icing in Lieu of De-Icing Which Will Pay for the Annual Cost of SCAN Ownership for Runway Configurations A, B and C.

The trade-offs between these two types of actions are plotted in Figure 22 for the two ice-control chemicals presently in use. Any combination of numbers of inappropriate applications of anti-icing chemicals and timely anti-icing operations that preclude subsequent de-icing operations obtained from the curves yields a cost saving equal to the annual SCAN system cost. For example, assume that urea is the ice-control chemical used at a "local" airport with a runway configuration A. The SCAN system will pay for itself if it prevents the inappropriate application of urea for anti-icing 22 times each year. Similarly, cost equivalency is obtained if five inappropriate anti-icing operations are prevented and on eleven occasions anti-icing is performed which eliminates de-icing requirements.

It is evident from Figure 22 that a SCAN system will pay for itself if it can, in fact, preclude the "misapplication" of ice-control chemicals on relatively few occasions. This is particularly true at airports where large runway surfaces must be maintained free of ice and snow and the on-site cost of ice-control chemicals is high. Obviously, a limited SCAN installation, i.e., fewer sensors than are assumed in the foregoing analysis, would be even more cost effective.
